Technical Service Bulletin		Body Electrical
BE-00188T-TME Version 1 24 Oct 2019	Subject: Toyota Touch 2 (MM17) - Fix for Hands-Free Bluetooth bad audio quality with Denso-TEN DCU RAV4 Area of Application: All Markets Models – Model Codes: RAV4 - AXAA52, AXAA54, AXAH52, AXAH54, MXAA52, MXAA54 ;

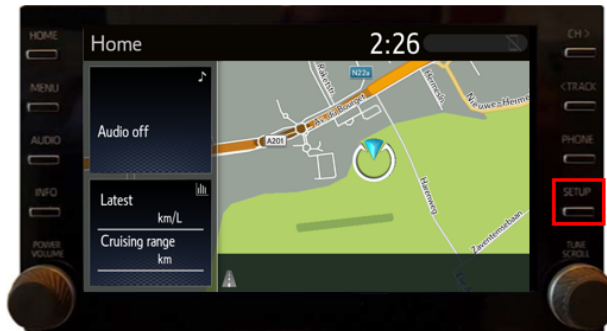
2. Let the multimedia system start up completely until the Home Screen is displayed.
3. Press "Setup", located on the side of the head unit.

Note Location may differ based on the unit version. Image is indicative.

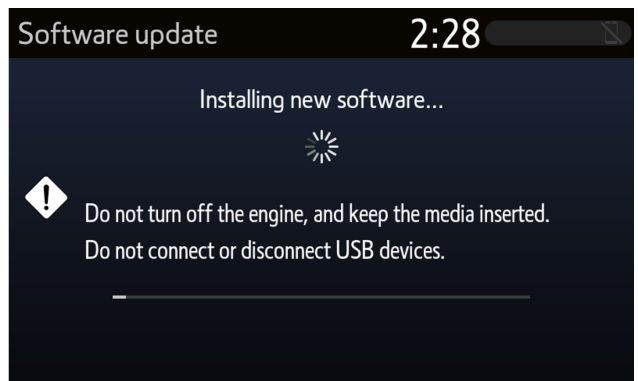
9. A pop-up will appear displaying the size of the update. Select "Yes" to start the update. A screen with a progress bar will be shown. This process will take around 20 minutes for MEU update.

Note follow recommendations appearing in screen. The file size shown below might not match the size of the file.
