## Technical Service Bulletin

BE-00141T-TME

**Toyota Touch 2 with Go (MM17) - Software fixes for MEU**

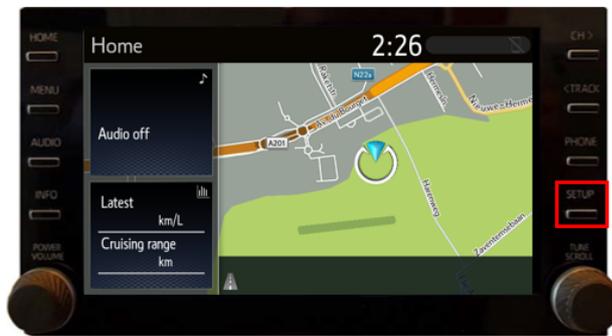
3. Press "Setup", located on the side of the head unit.

Note Location may differ based on the unit version. Image is indicative.

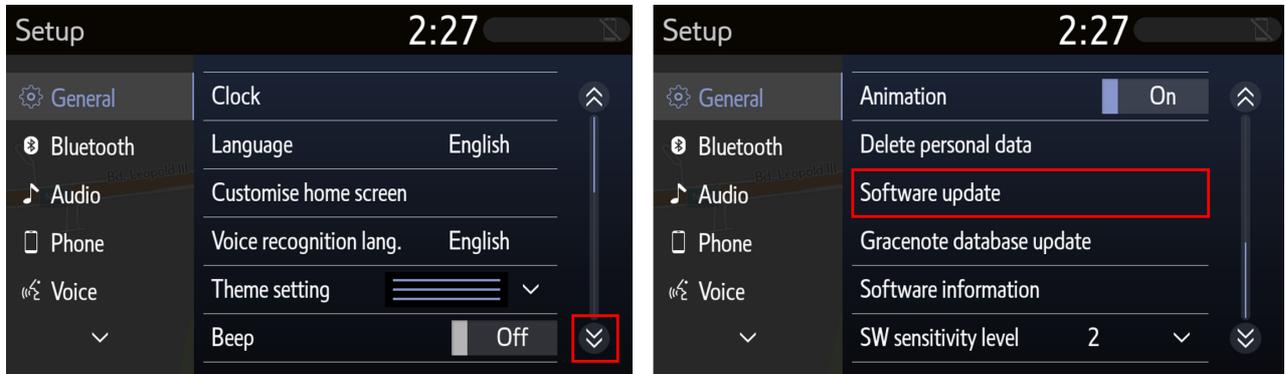
4. In the "Setup" menu, scroll down and select "Software Update".

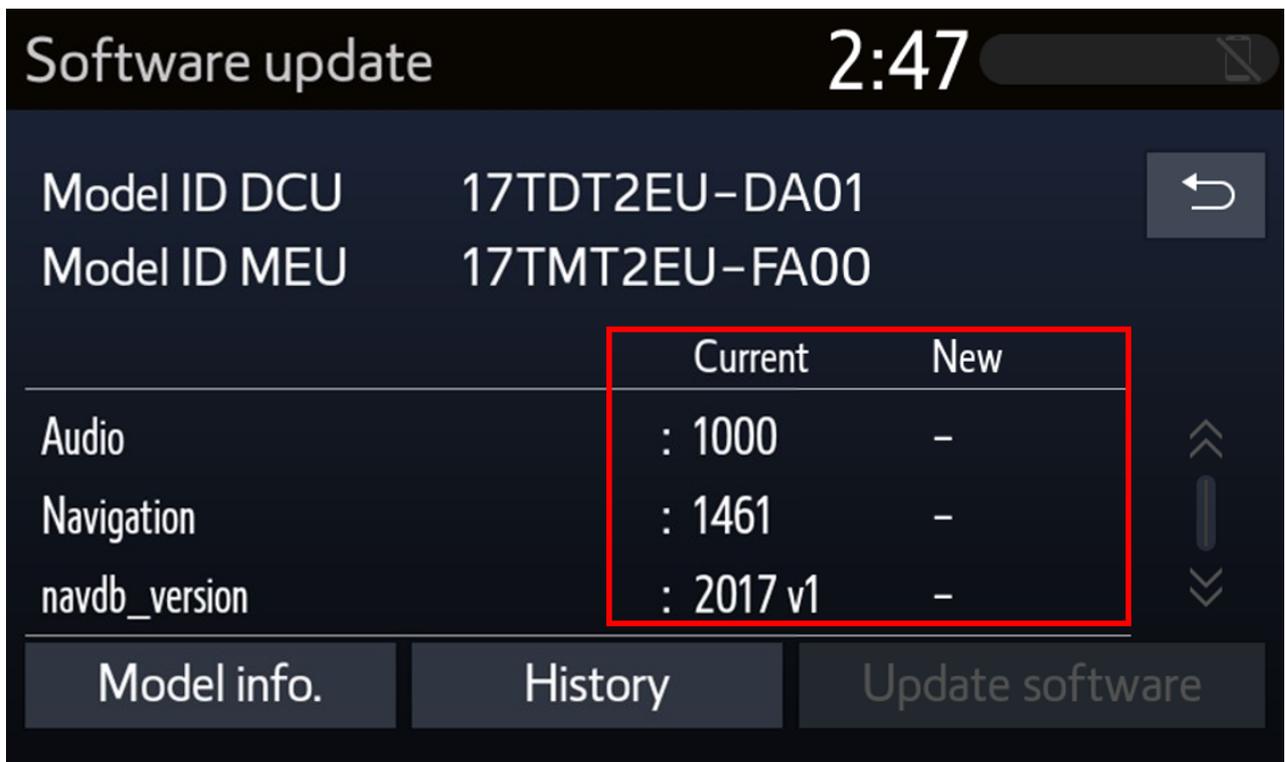
5. In the "Software update" menu: the current installed software is displayed. The MEU software is listed under "Navigation".

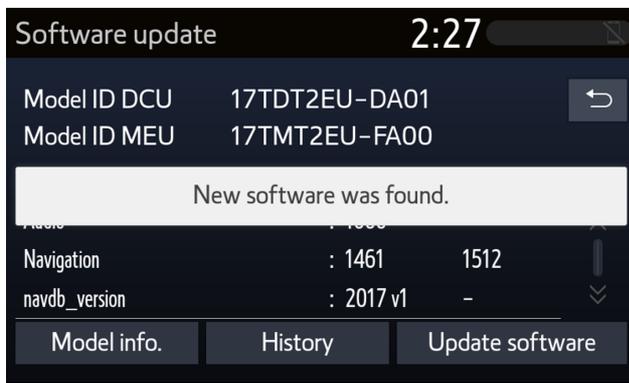
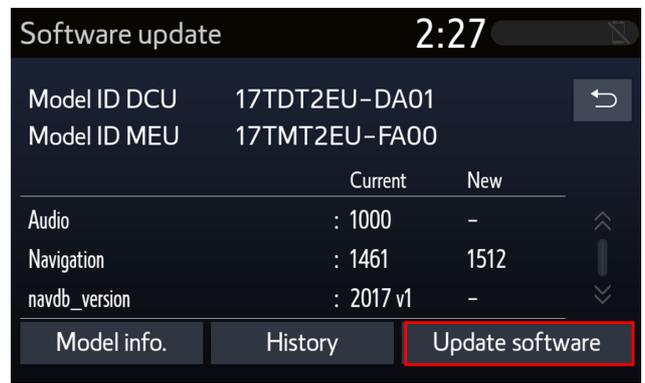
7. The new version of the MEU software will be displayed. Confirm by pressing "Update software".

Note The SW version shown in the image is not necessarily the latest version.

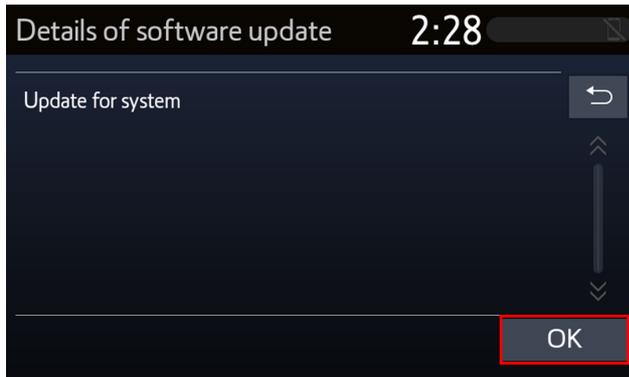
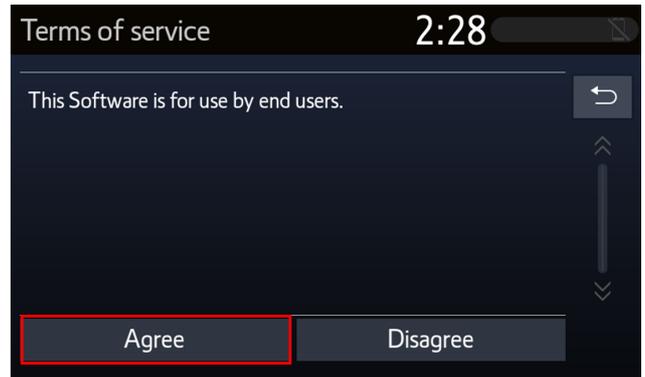
8. The details of the software update will be displayed: select "OK". Next screen are the "Terms of service": select "Agree" to proceed with the update.

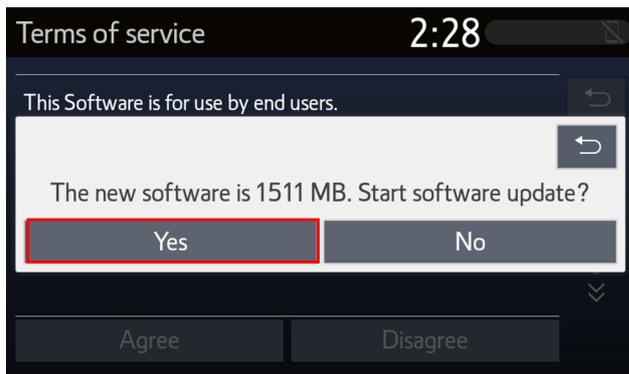
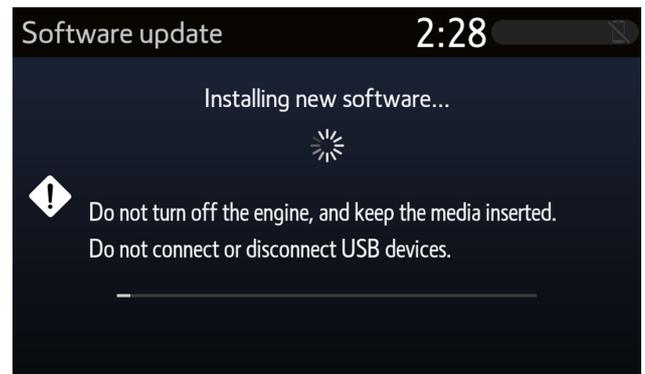
9. A pop-up will appear displaying the size of the update. Select "Yes" to start the update. A screen with a progress bar will be shown. This process will take around 20 minutes for MEU update.

Note follow recommendations appearing in screen.

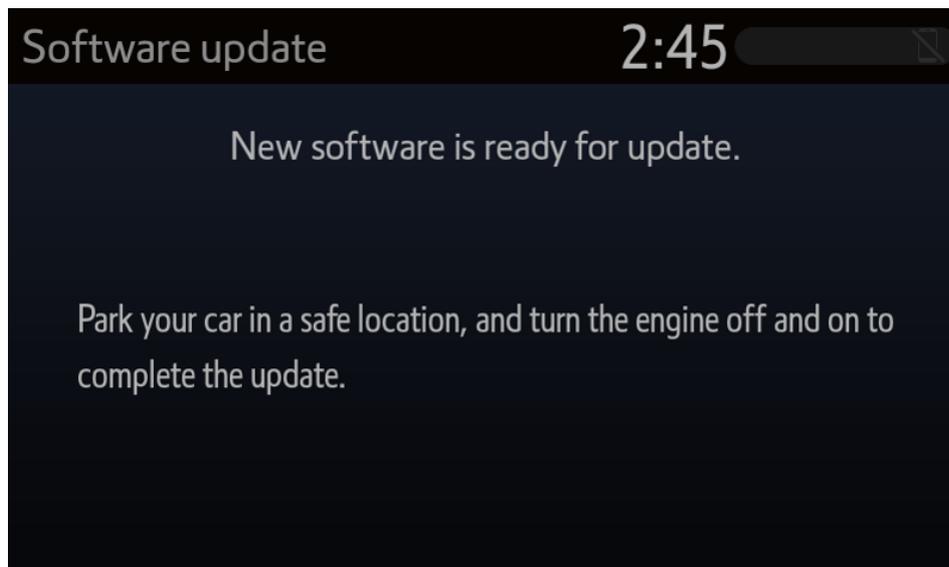
10. Wait to get the screen confirming that the update is ready, follow the safety recommendations.

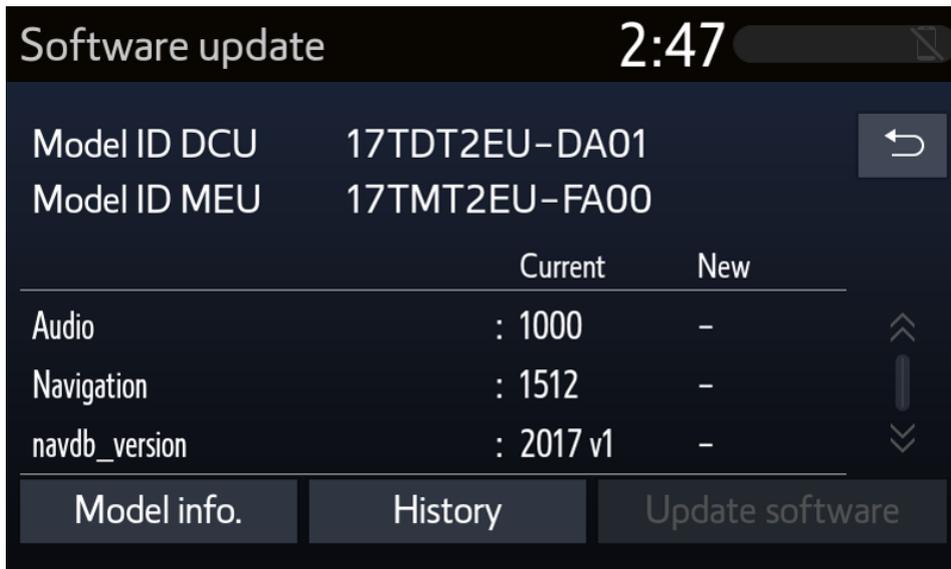
Go back to the "Software update" menu to verify that the correct software has been installed and. The newly installed MEU software is now displayed under current software.

Note The SW version shown in the image is not necessarily the latest version
